**A STUDY OF TRAIL DEGRADATION
ALONG THE PAT SIN RANGE,
NORTH NEW TERRITORIES, HONG KONG**

Thesis submitted to the Graduate School
of the Chinese University of Hong Kong
in partial fulfilment of the requirements
for the degree of Master of Philosophy

June, 1992

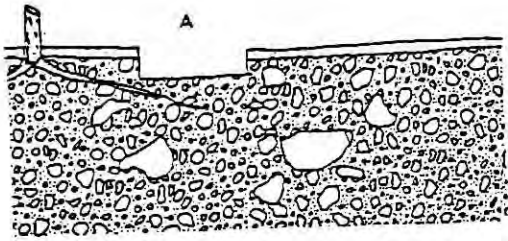
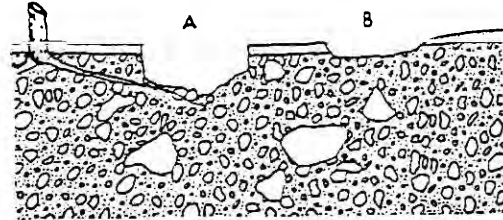
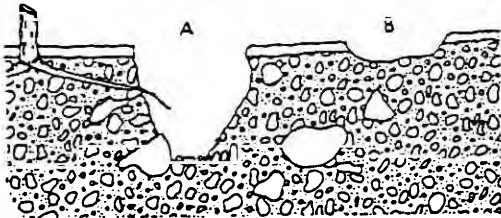
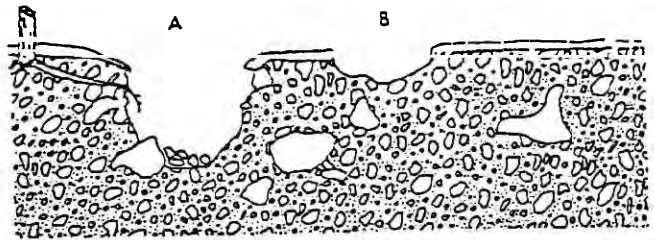
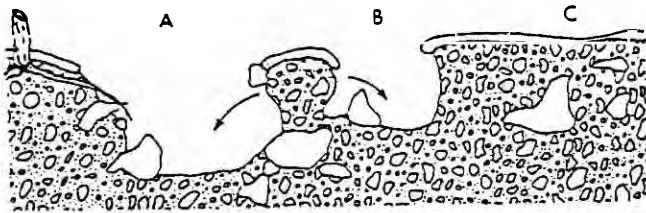
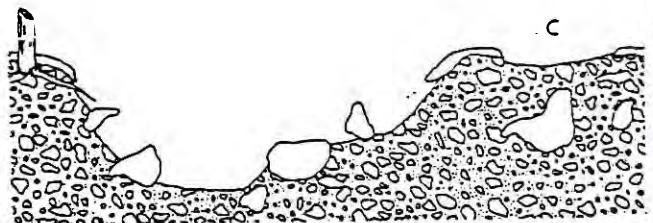
Figure 2.1 Graphical presentation of the trail degradation process.

Original condition. Trail (A) is constructed by removing turf overlying till.

Trail slightly eroded by running water partly exposing pebbles and small boulders. Trail becomes difficult to walk or ride on and is partly abandoned. New trail (B) worn parallel to old.

Trail deeply eroded by running water exposing large tree roots and boulders. Loose rocks in trail making walking and riding difficult or impossible. Trail is abandoned for new trail where undercutting of turf begins.

Trail further eroded. Vegetation and root mat is undercut, collapses, and is washed away. More boulders washed into rut, and additional roots exposed. Second trail begins to erode.

Second trail eroded to similar stage as old trail. Turf bank separating the two trails is further undercut, becoming unstable. Third trail (C) begins.

Turf bank collapses and is washed out by running water leaving large rut. Third trail begins to erode.

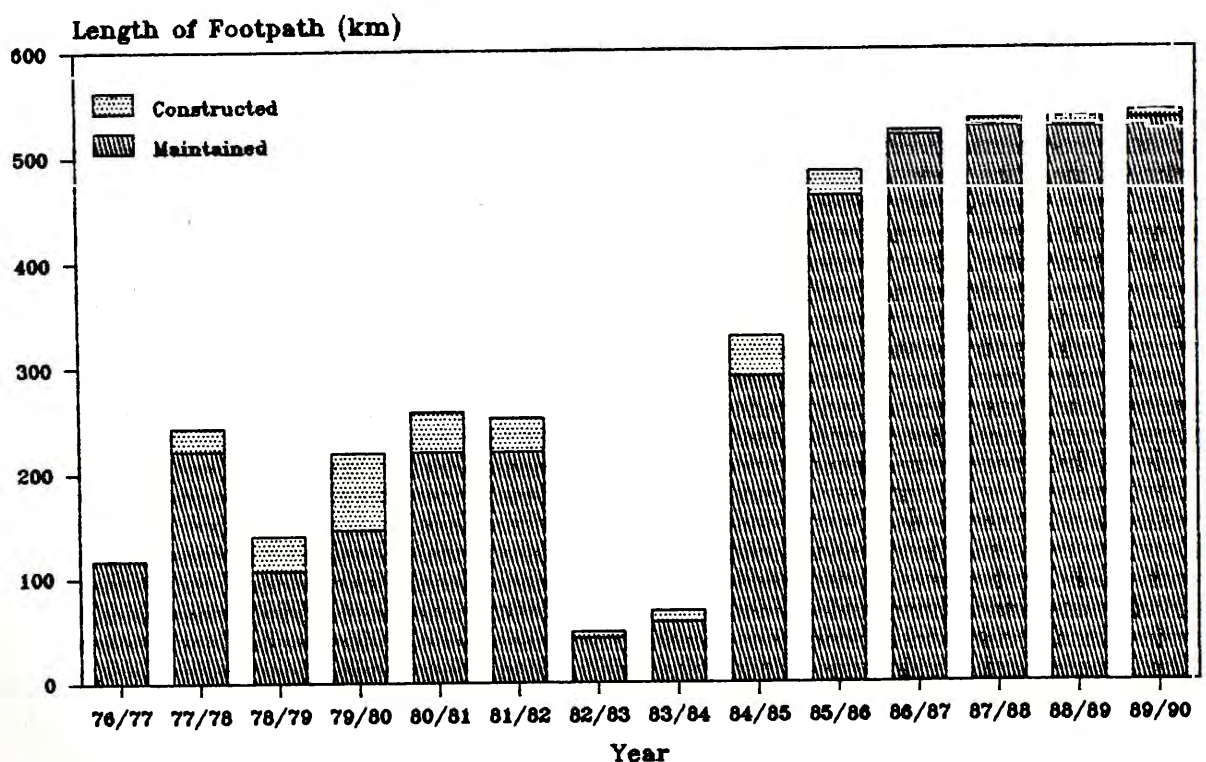
Figure 3.7
Footpath construction and maintenance
in the Country parks, 1976 – 1990

Most footpaths in Hong Kong's country parks are maintained rather than constructed (Figure 3.7). The priority of maintenance is generally given to those of easy accessibility and of interpretive use, such as the family walks and nature trails. In the Pat Sin Leng Country Park, most of the trails are located in the extensive zone and have a low maintenance priority.

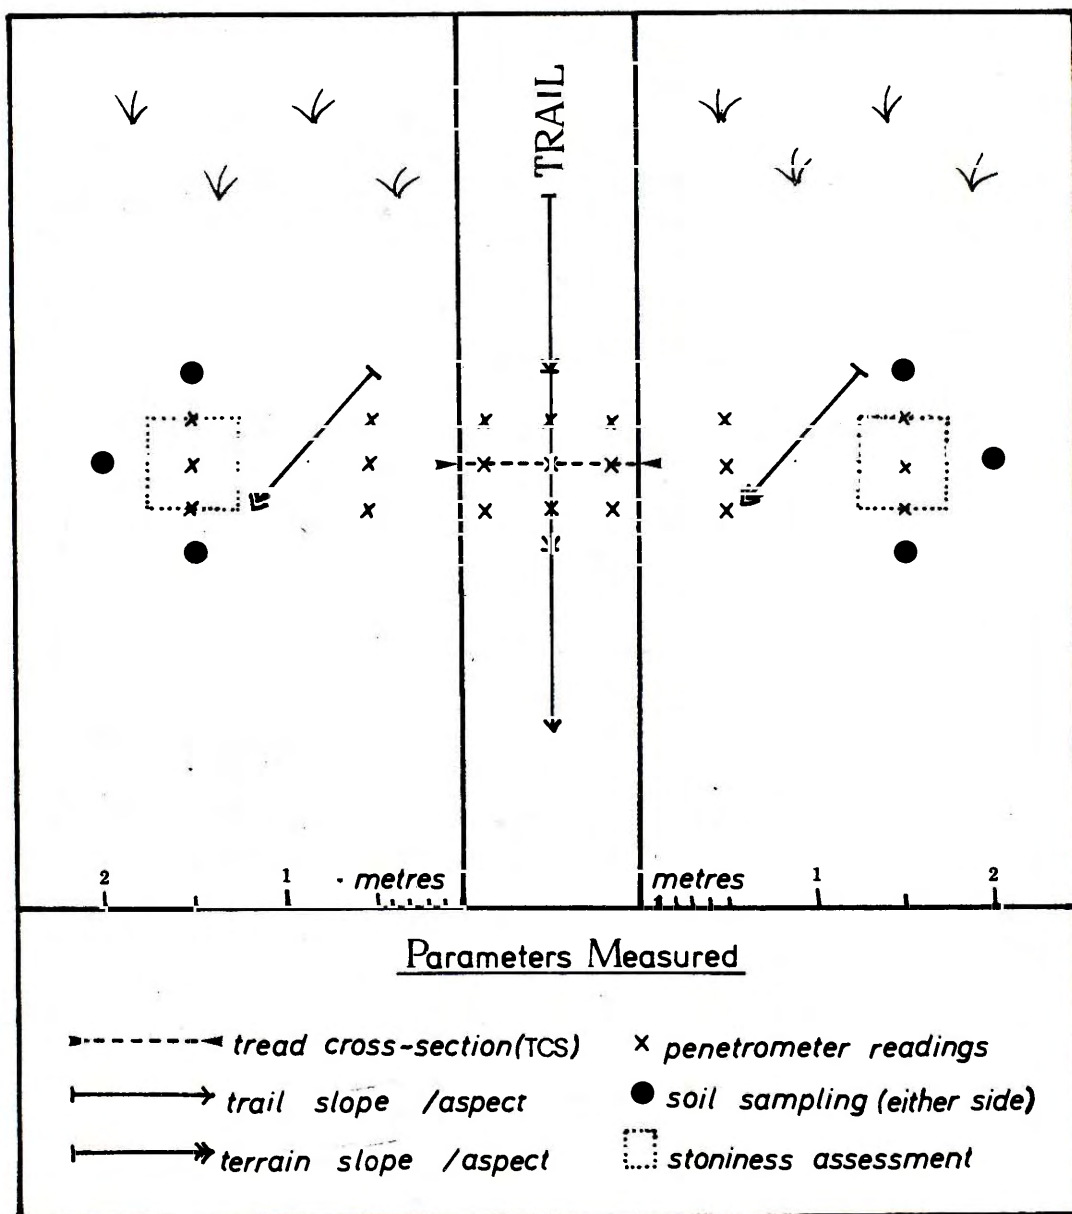
Figure 4.2
Sample design of field measurements at the sample sites.

The presence of bedrock outcrops prohibited the penetrometer measurement at several sample sites. This resulted in varied sample sizes at different positions within a site as well as amongst different sites. Moreover, when the penetration resistance reading exceeded the instrument's maximum at a measuring point where no impediment was found, the maximum value of 1 MPa was recorded at that measuring point. Hence, the results may to a certain extent underestimate the degree and the variation of compaction.

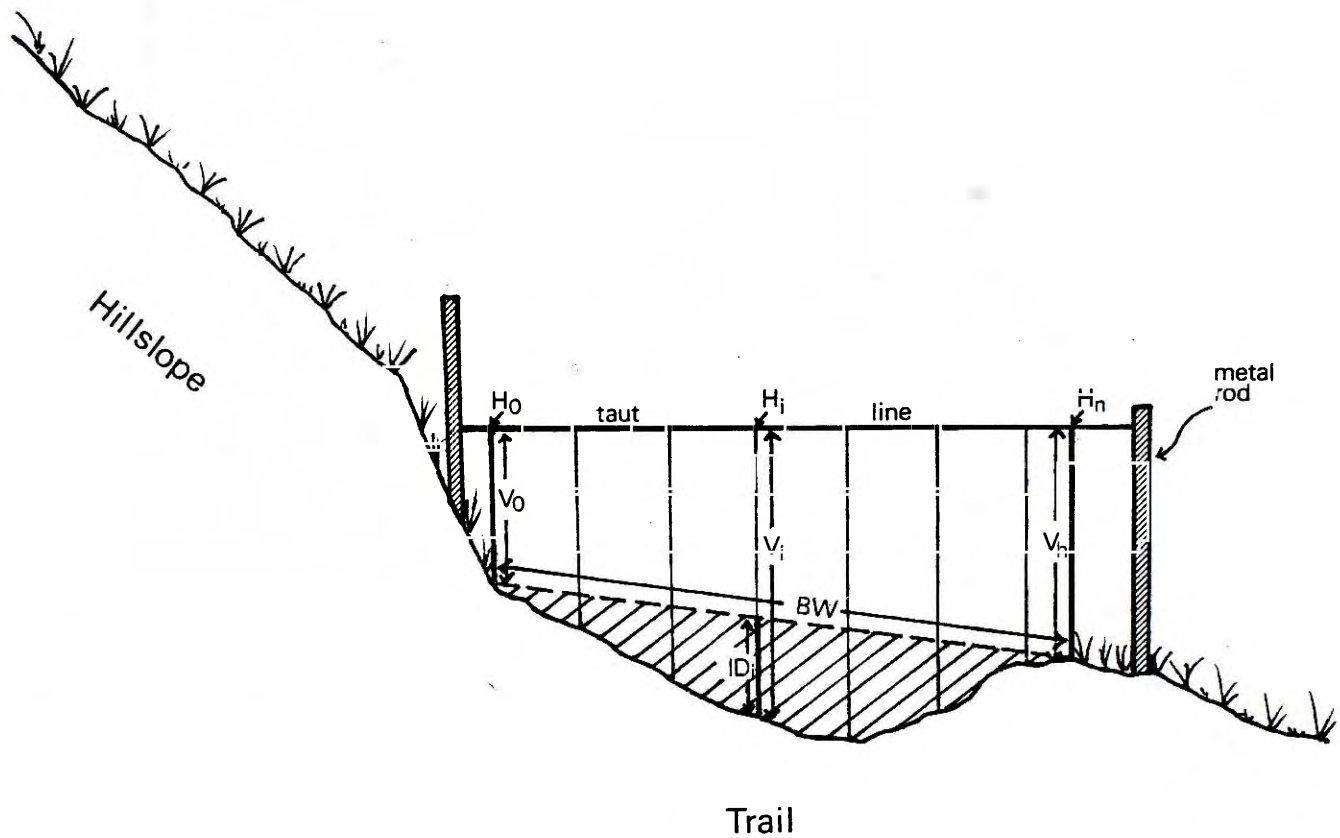
Figure 4.3
Field measurement of the
tread cross-section.

$$TCSA = \left\{ \sum_{i=1}^n [(V_i + V_{i-1})(H_i - H_{i-1})/2] \right\} - [(V_0 + V_n)(H_n - H_0)/2]$$

$$ID_i = V_i - H_0 - [(H_i - H_0)(V_n - V_0)/(H_n - H_0)]$$

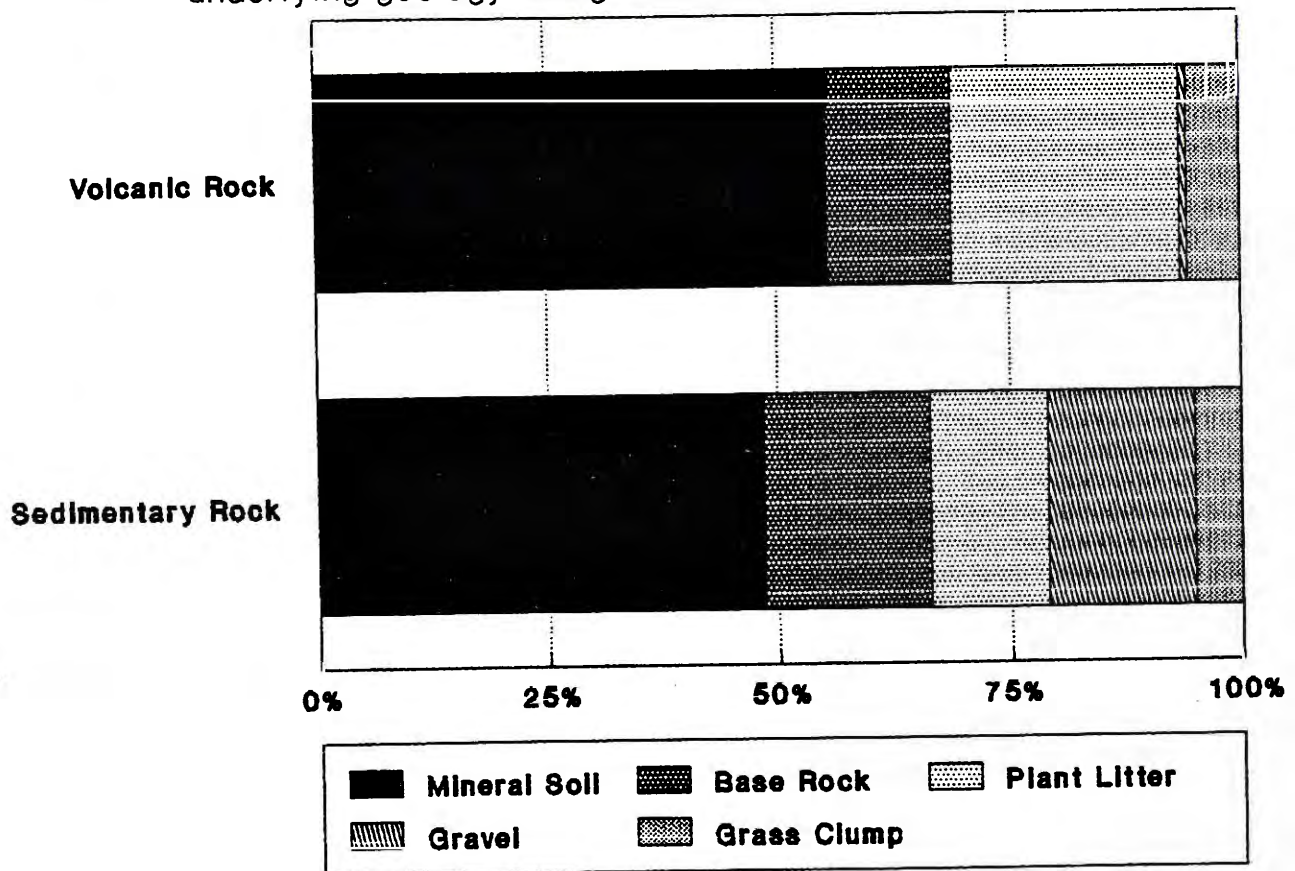
The composition of tread surface material with respect to underlying geology along the Pat Sin Range Trail.

litter and gravels between the two parent rocks.

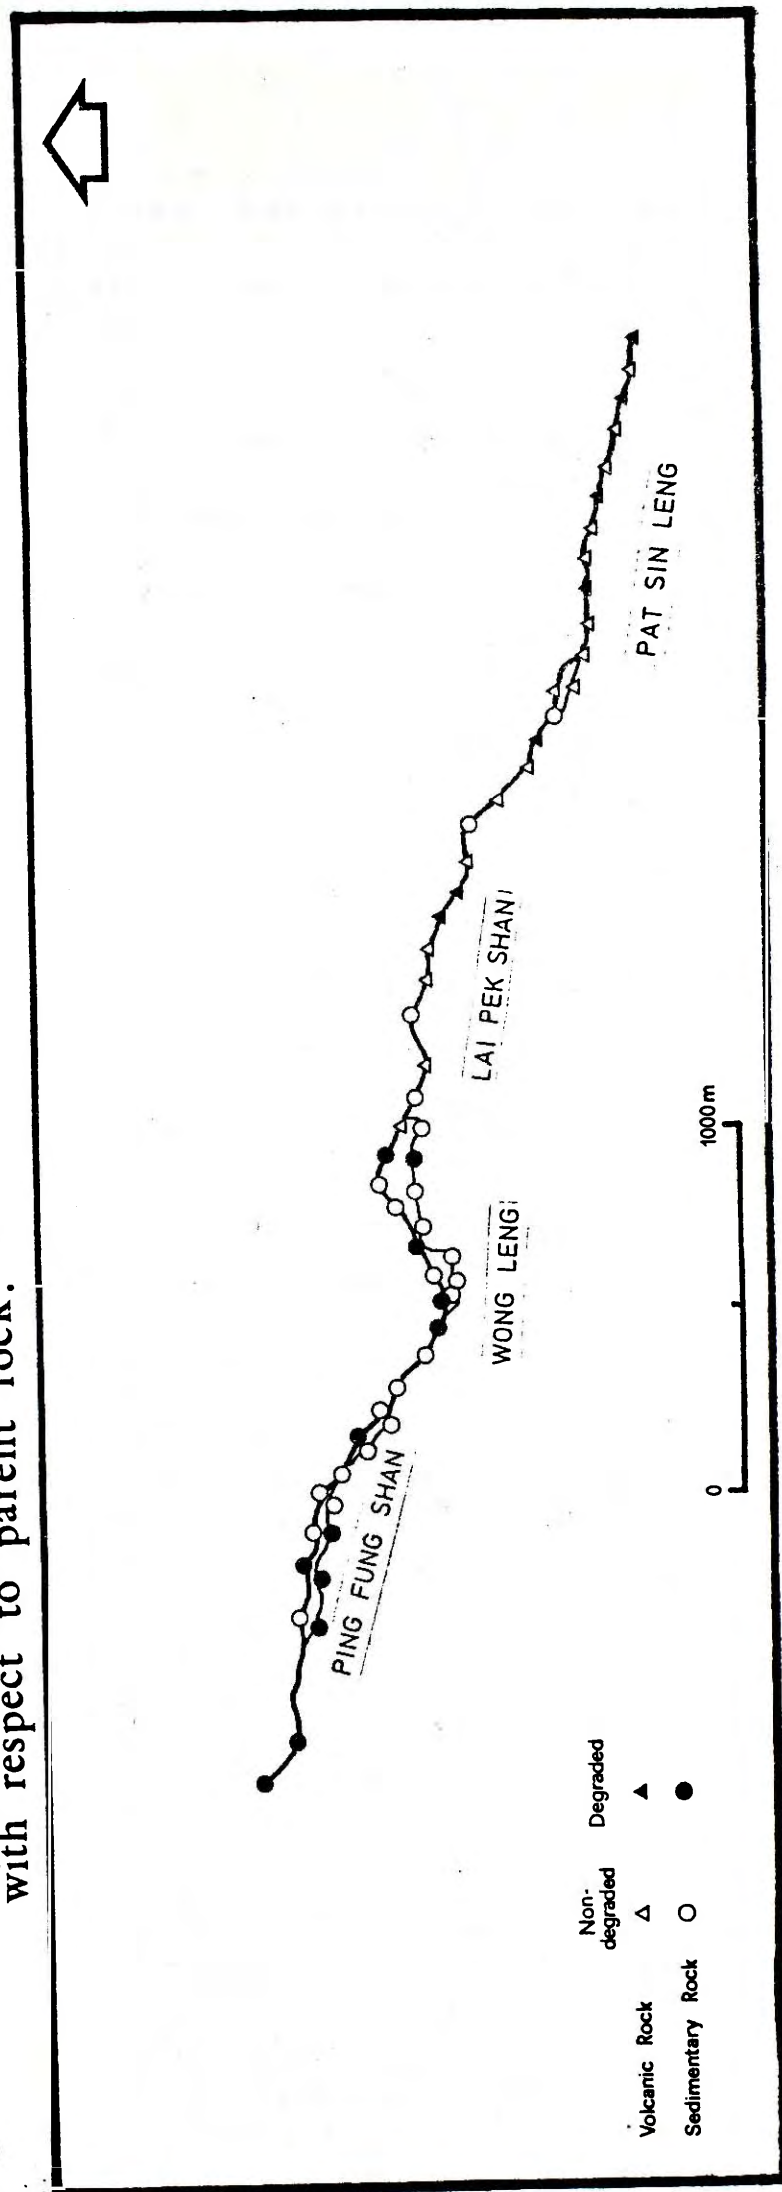
Figure 5.6 Degradation class of the sample sites along the PSR Trail, with respect to parent rock.

Leng and Ping Fung Shan nevertheless have a greater chance of being classified as degraded sites.

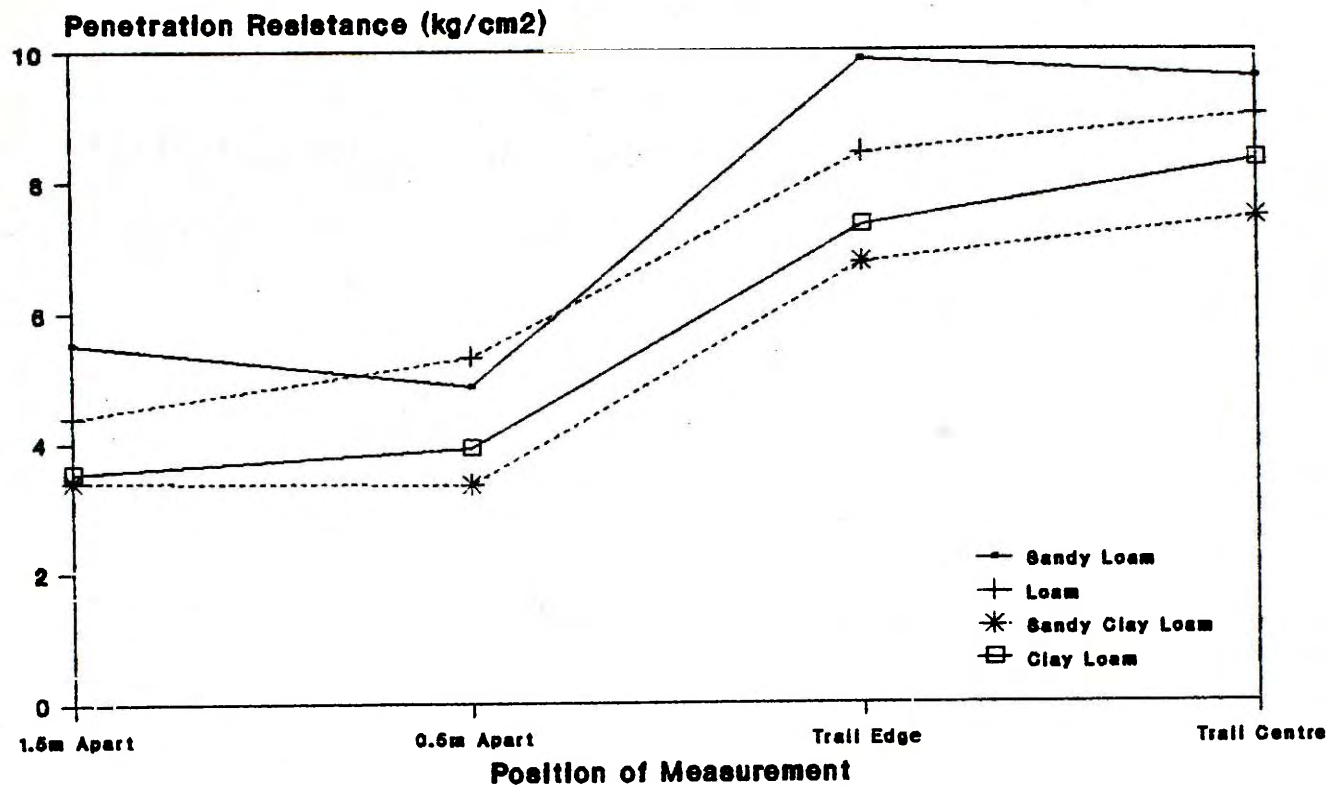
Figure 6.2
Change of penetration resistance across
the tread with respect to soil texture.

It may be concluded from the above analyses that the influence of parent material on trail morphology is quite limited, but that there are close relationships between trail compaction and soil properties, especially those indicative of soil texture.

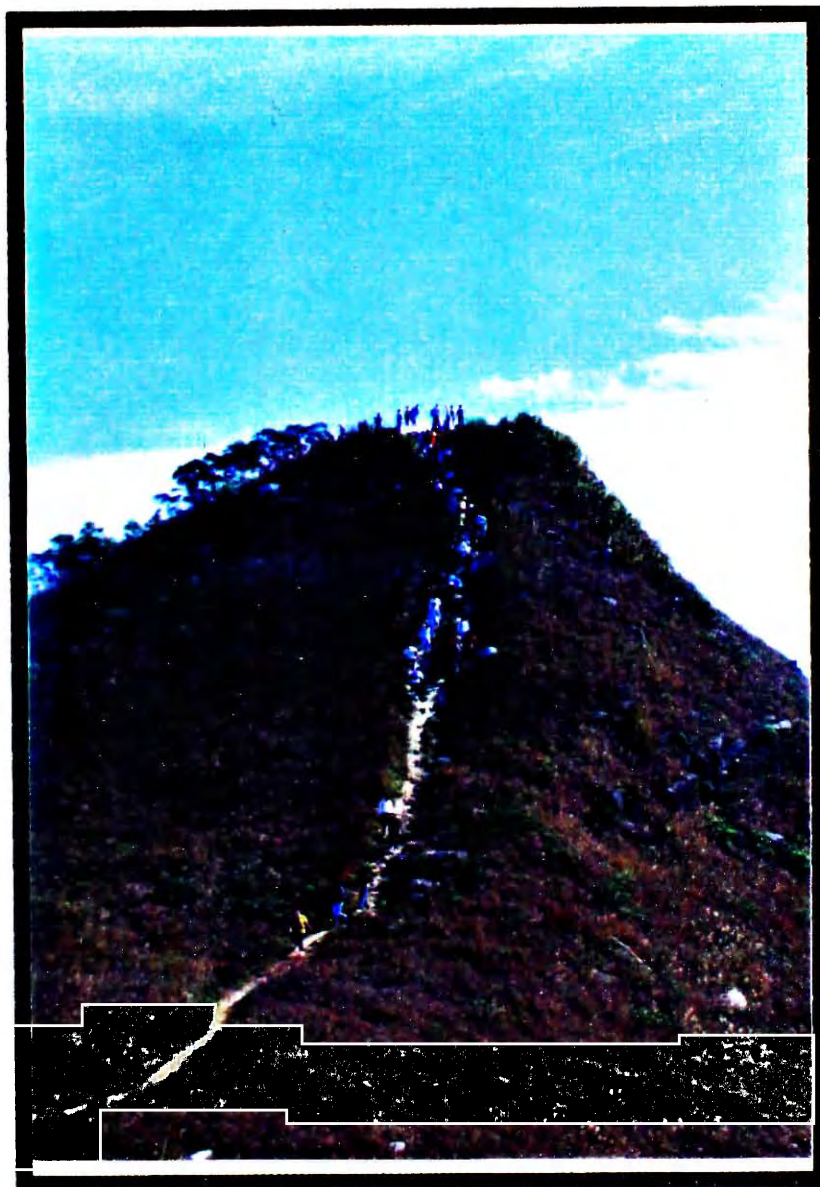
Plate 6.1 Lateral spread of hikers on the west-facing slope at Hsien Ku Fung (the first crest of Pat Sin Leng from east). Note the spread is mainly on the upper part of the slope.

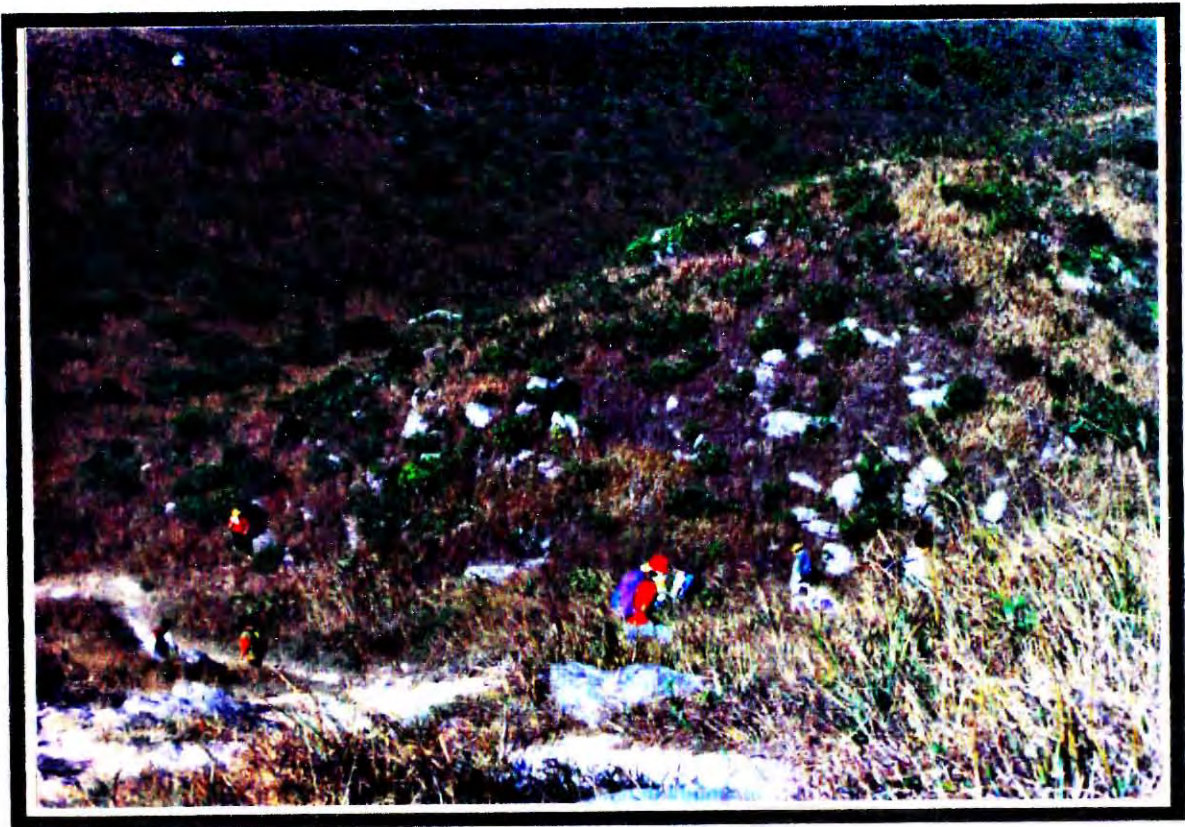
Plate 6.2 An example showing the wandering off-trail of hikers on the west-facing slope at Sheung Tsz Fung (the second crest of Pat Sin Leng from east).

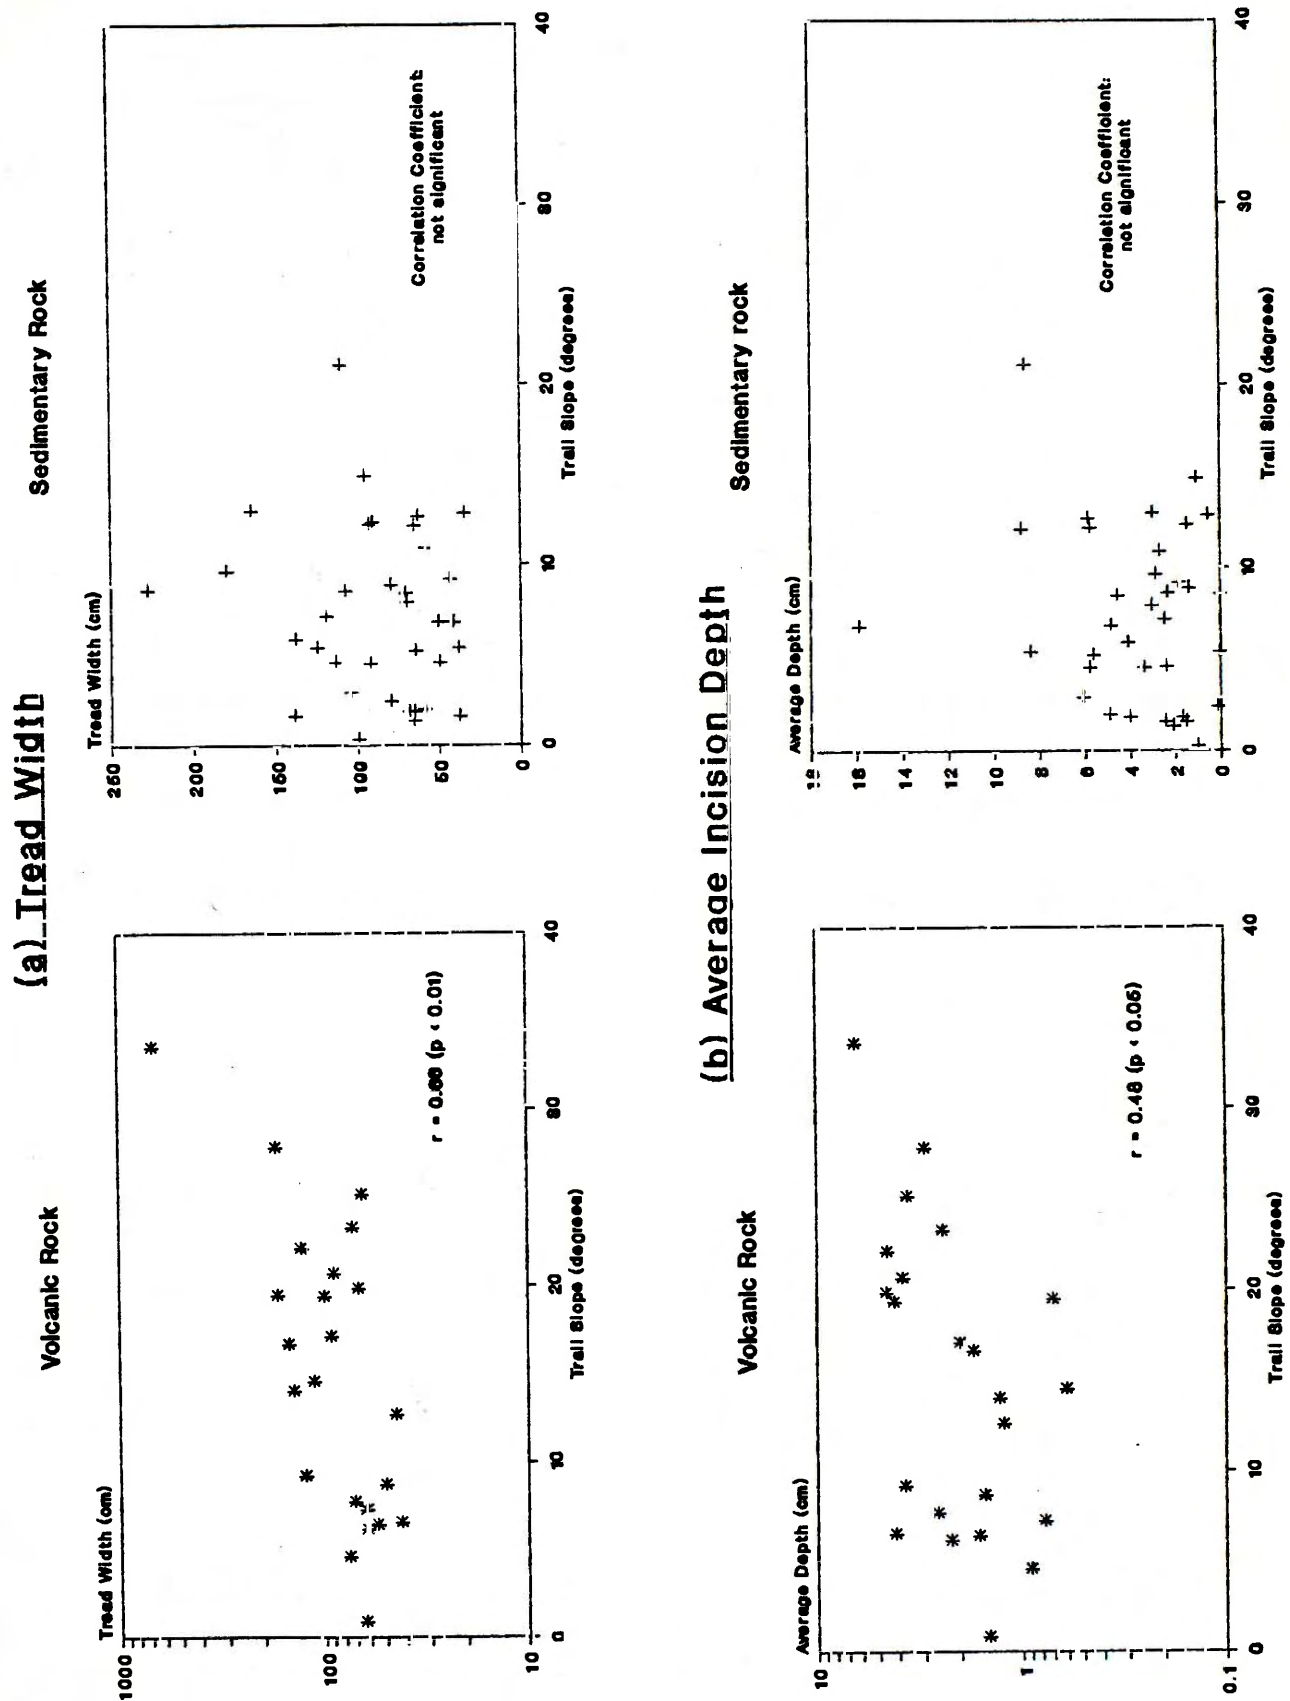
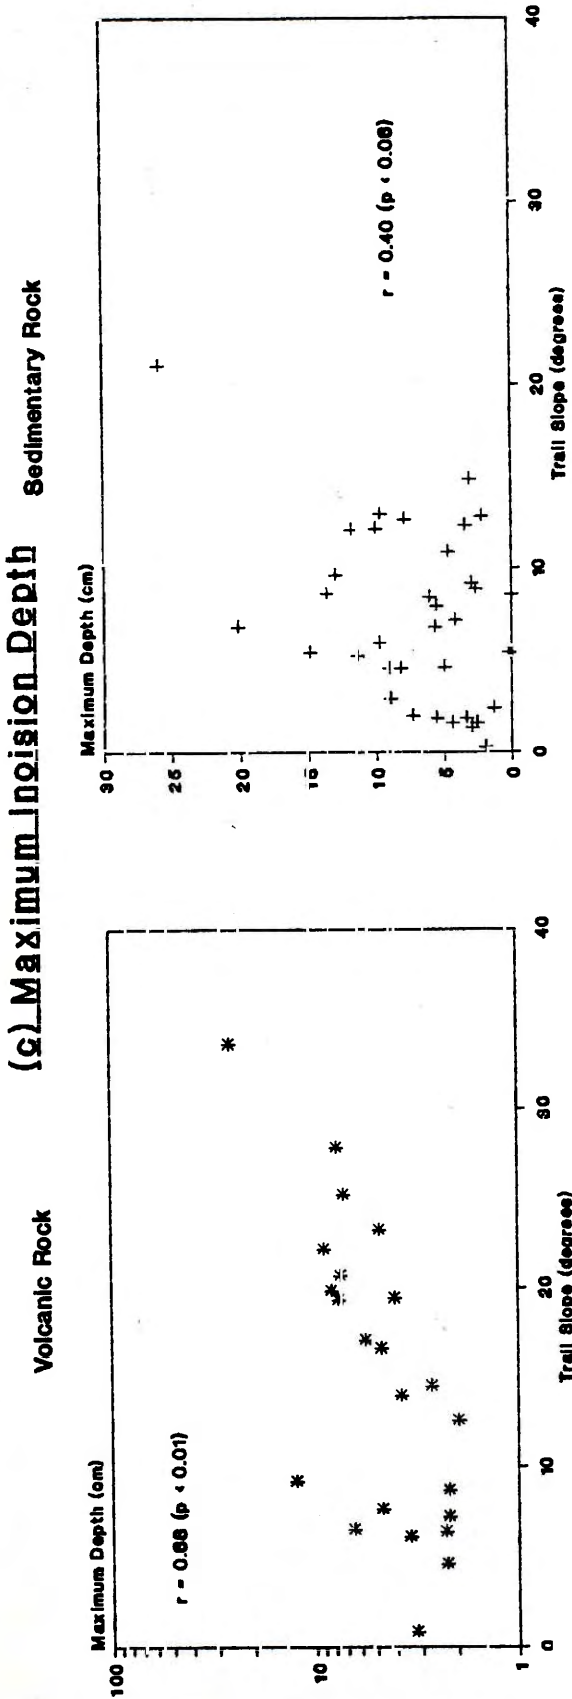
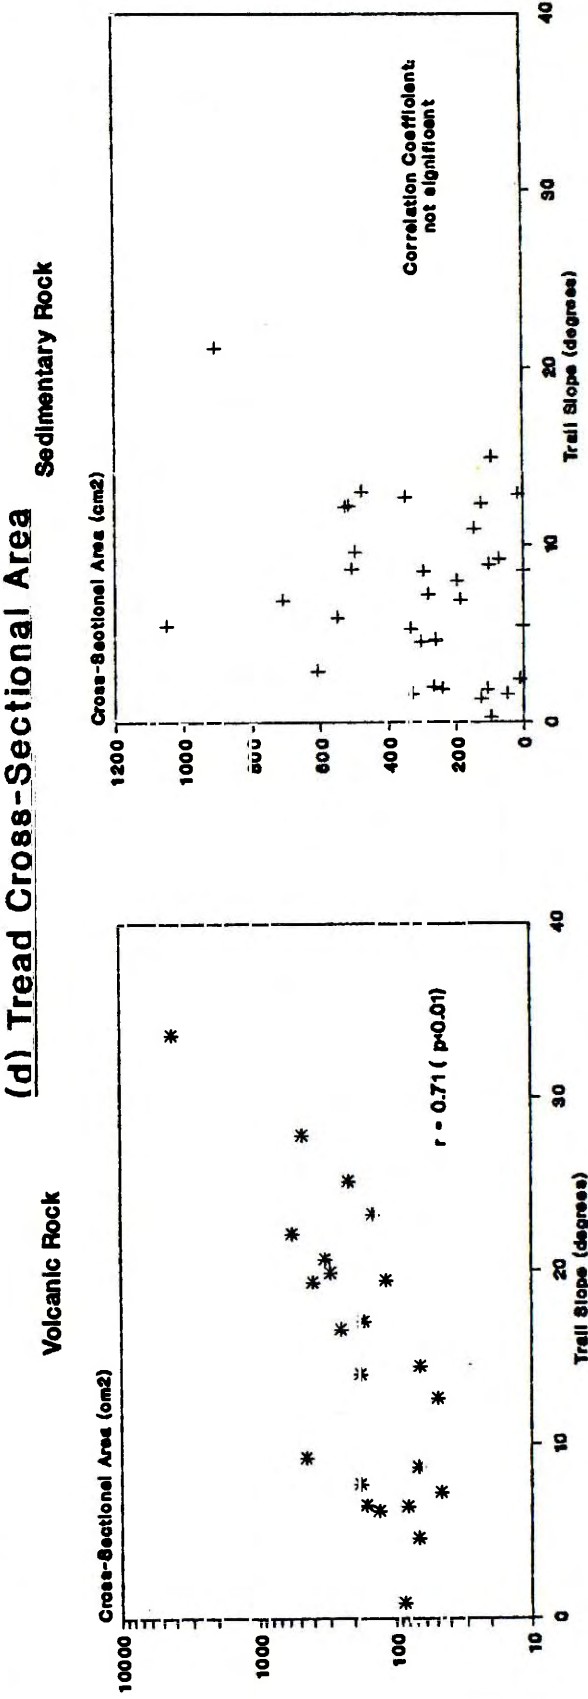
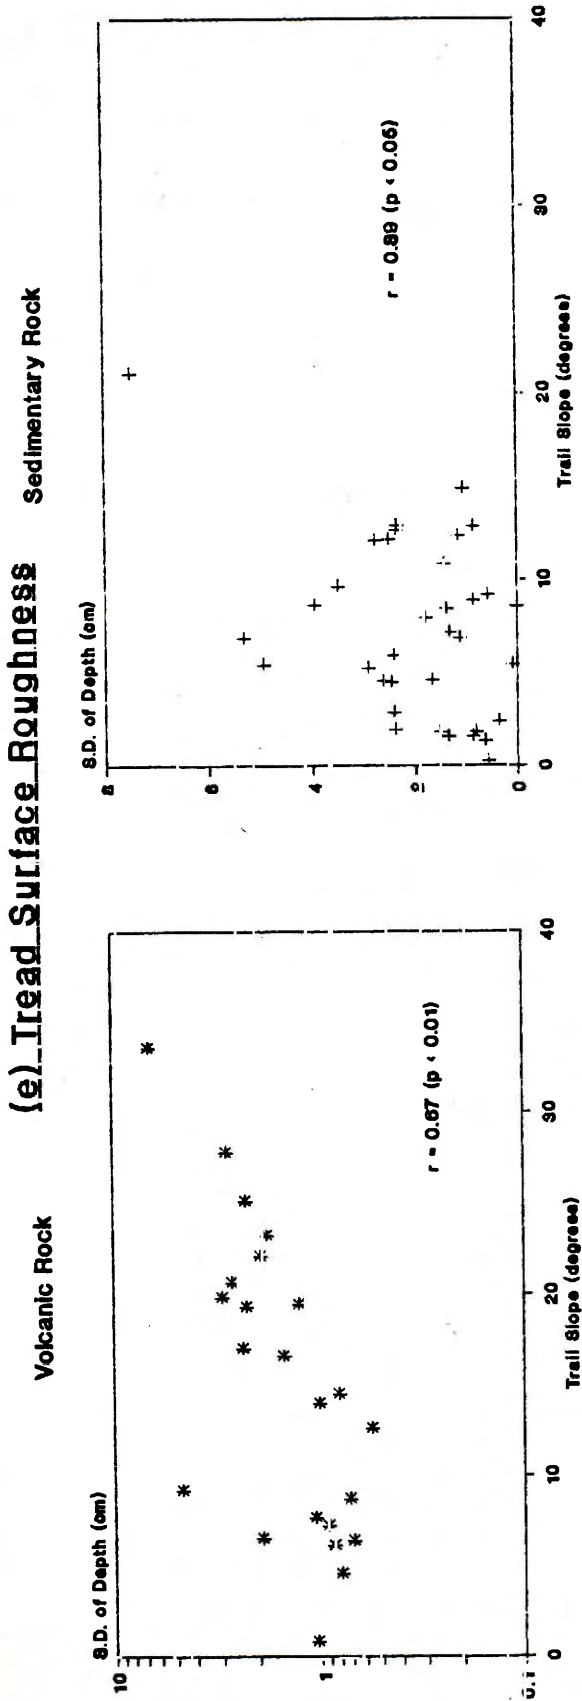
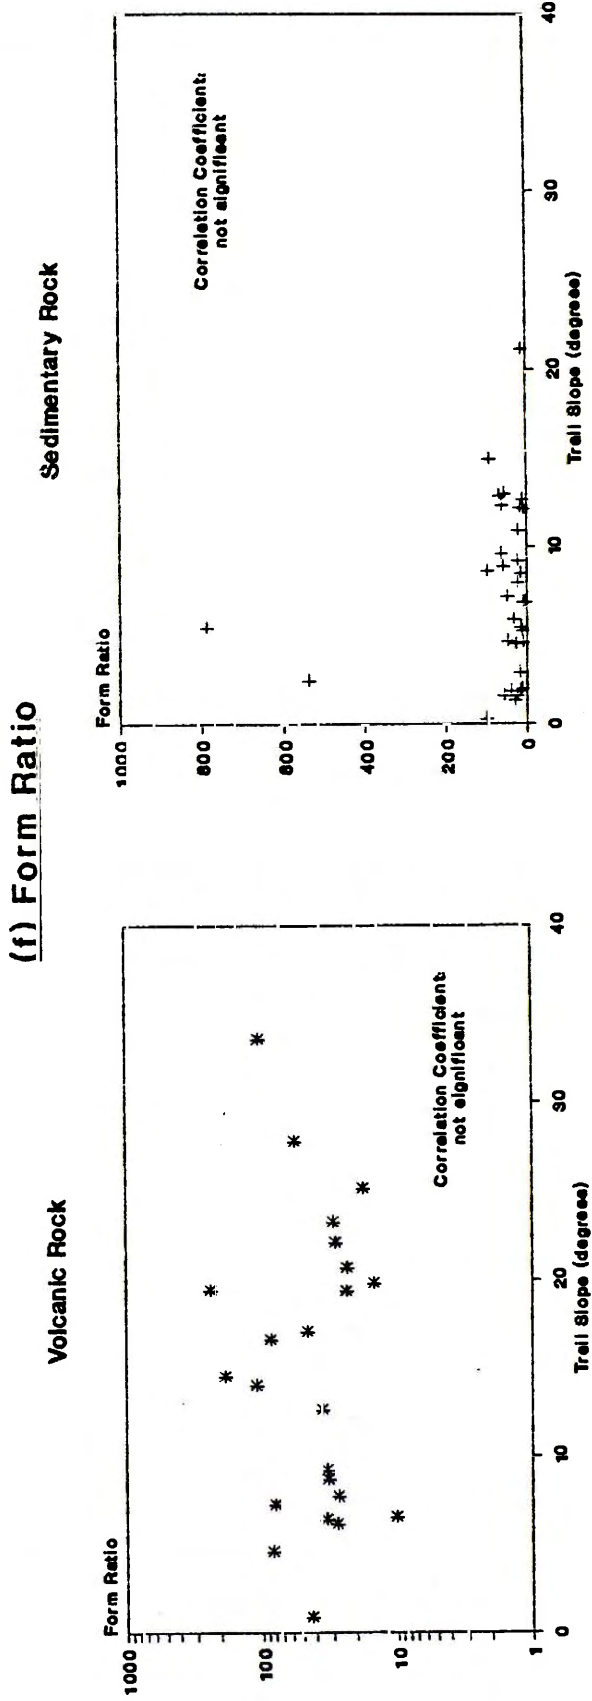
The relationship between trail slope and trail morphology with respect to parent rock.

This contrast in response may be partly explained by the inherently higher susceptibility to erosion of the volcanic-derived soil. In addition, the finer-textured and probable moister tread surface when wet (especially after rains) further aggravates the walking condition and promotes wandering behaviour on steep ground. These two specific characteristics on volcanic rock may interact and result in the exponential response of trail degradation to the increase of trail slope. In fact, the exponential relationship between slope steepness and soil erosion by trampling has been reported elsewhere (Quinn et al., 1980).

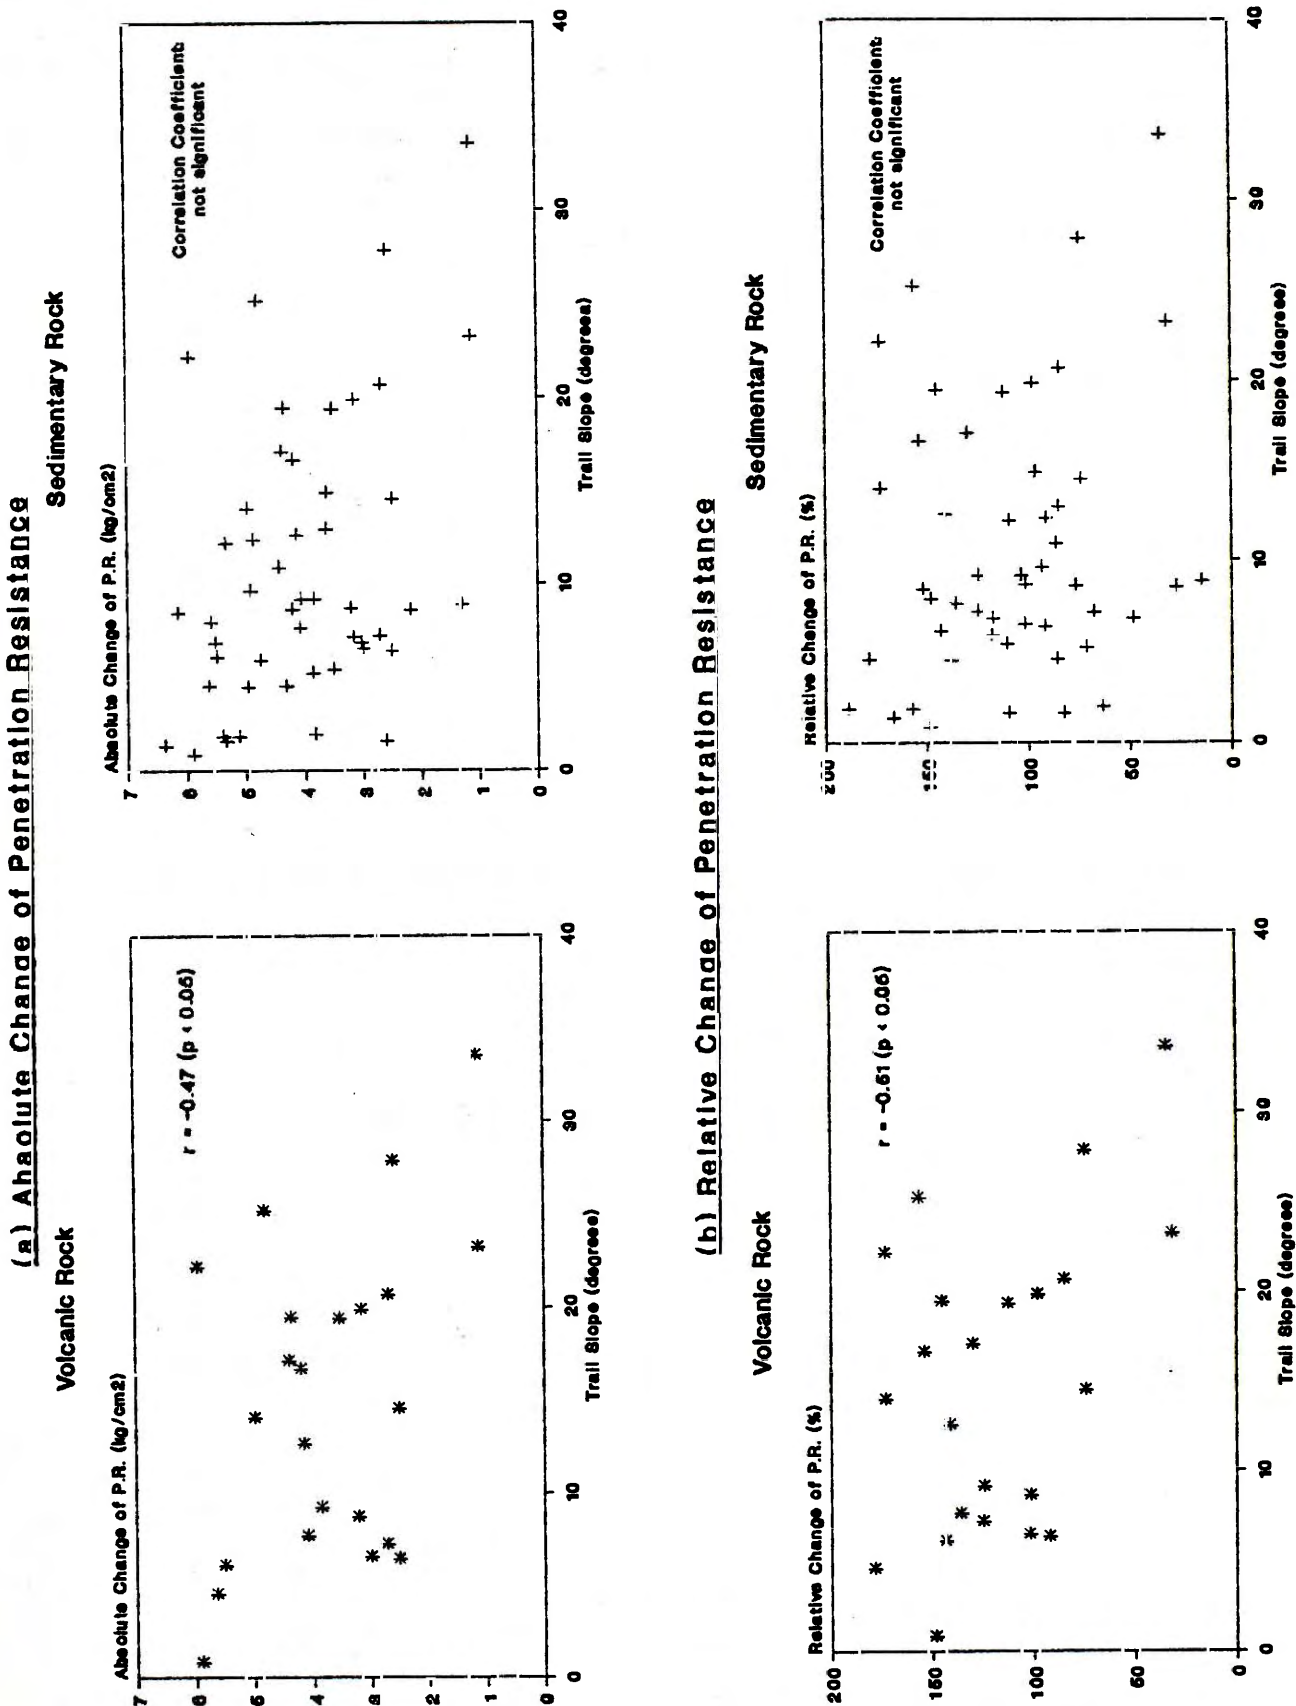
The relationship between trail slope and trail compaction with respect to parent rock.

On the other hand, the positive relationship between trail slope and trail morphology and the inverse relationship between trail slope and compaction suggest that morphological degradation and tread compaction could be two divergent processes and do not necessarily conform to the common theory that erosion is promoted by compaction.

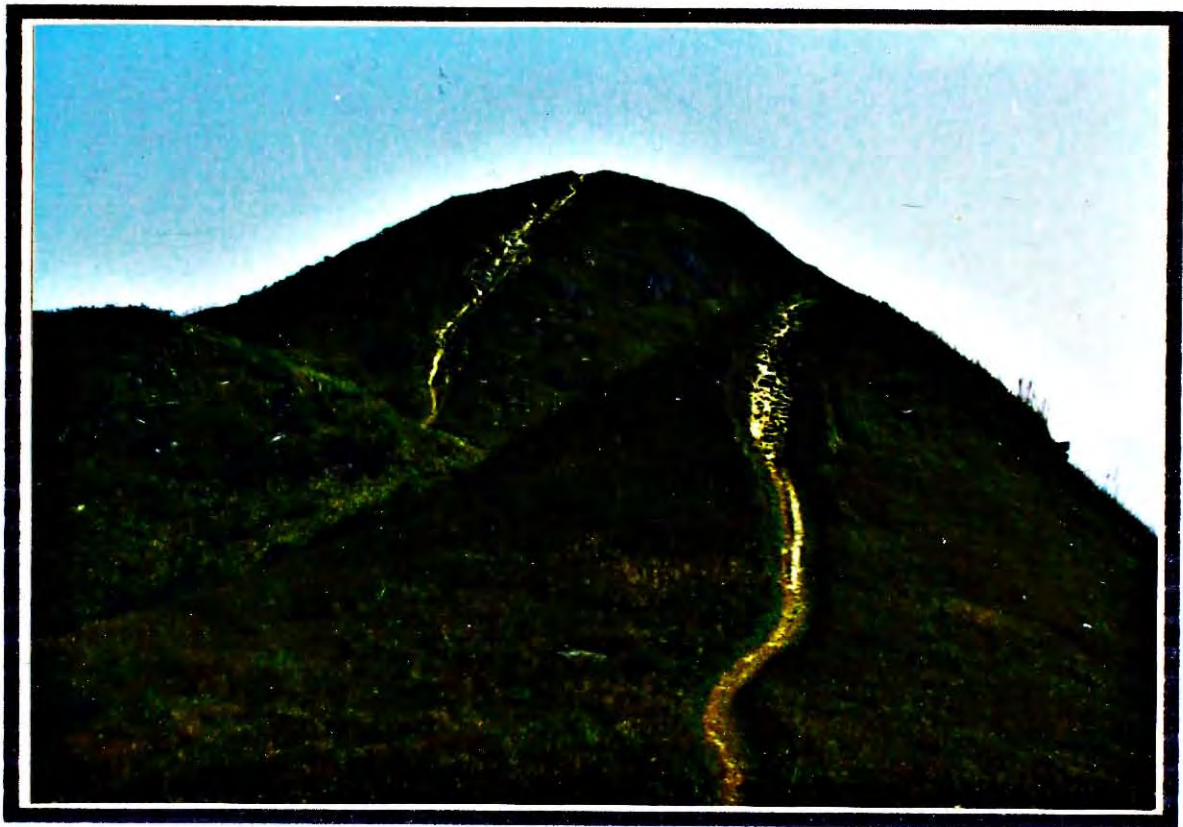
Plate 6.3 Trail degradation on the upper slope positions of the west-facing slopes at Pat Sin Leng. Note the wide bare width and the developing multiple treads alongside.

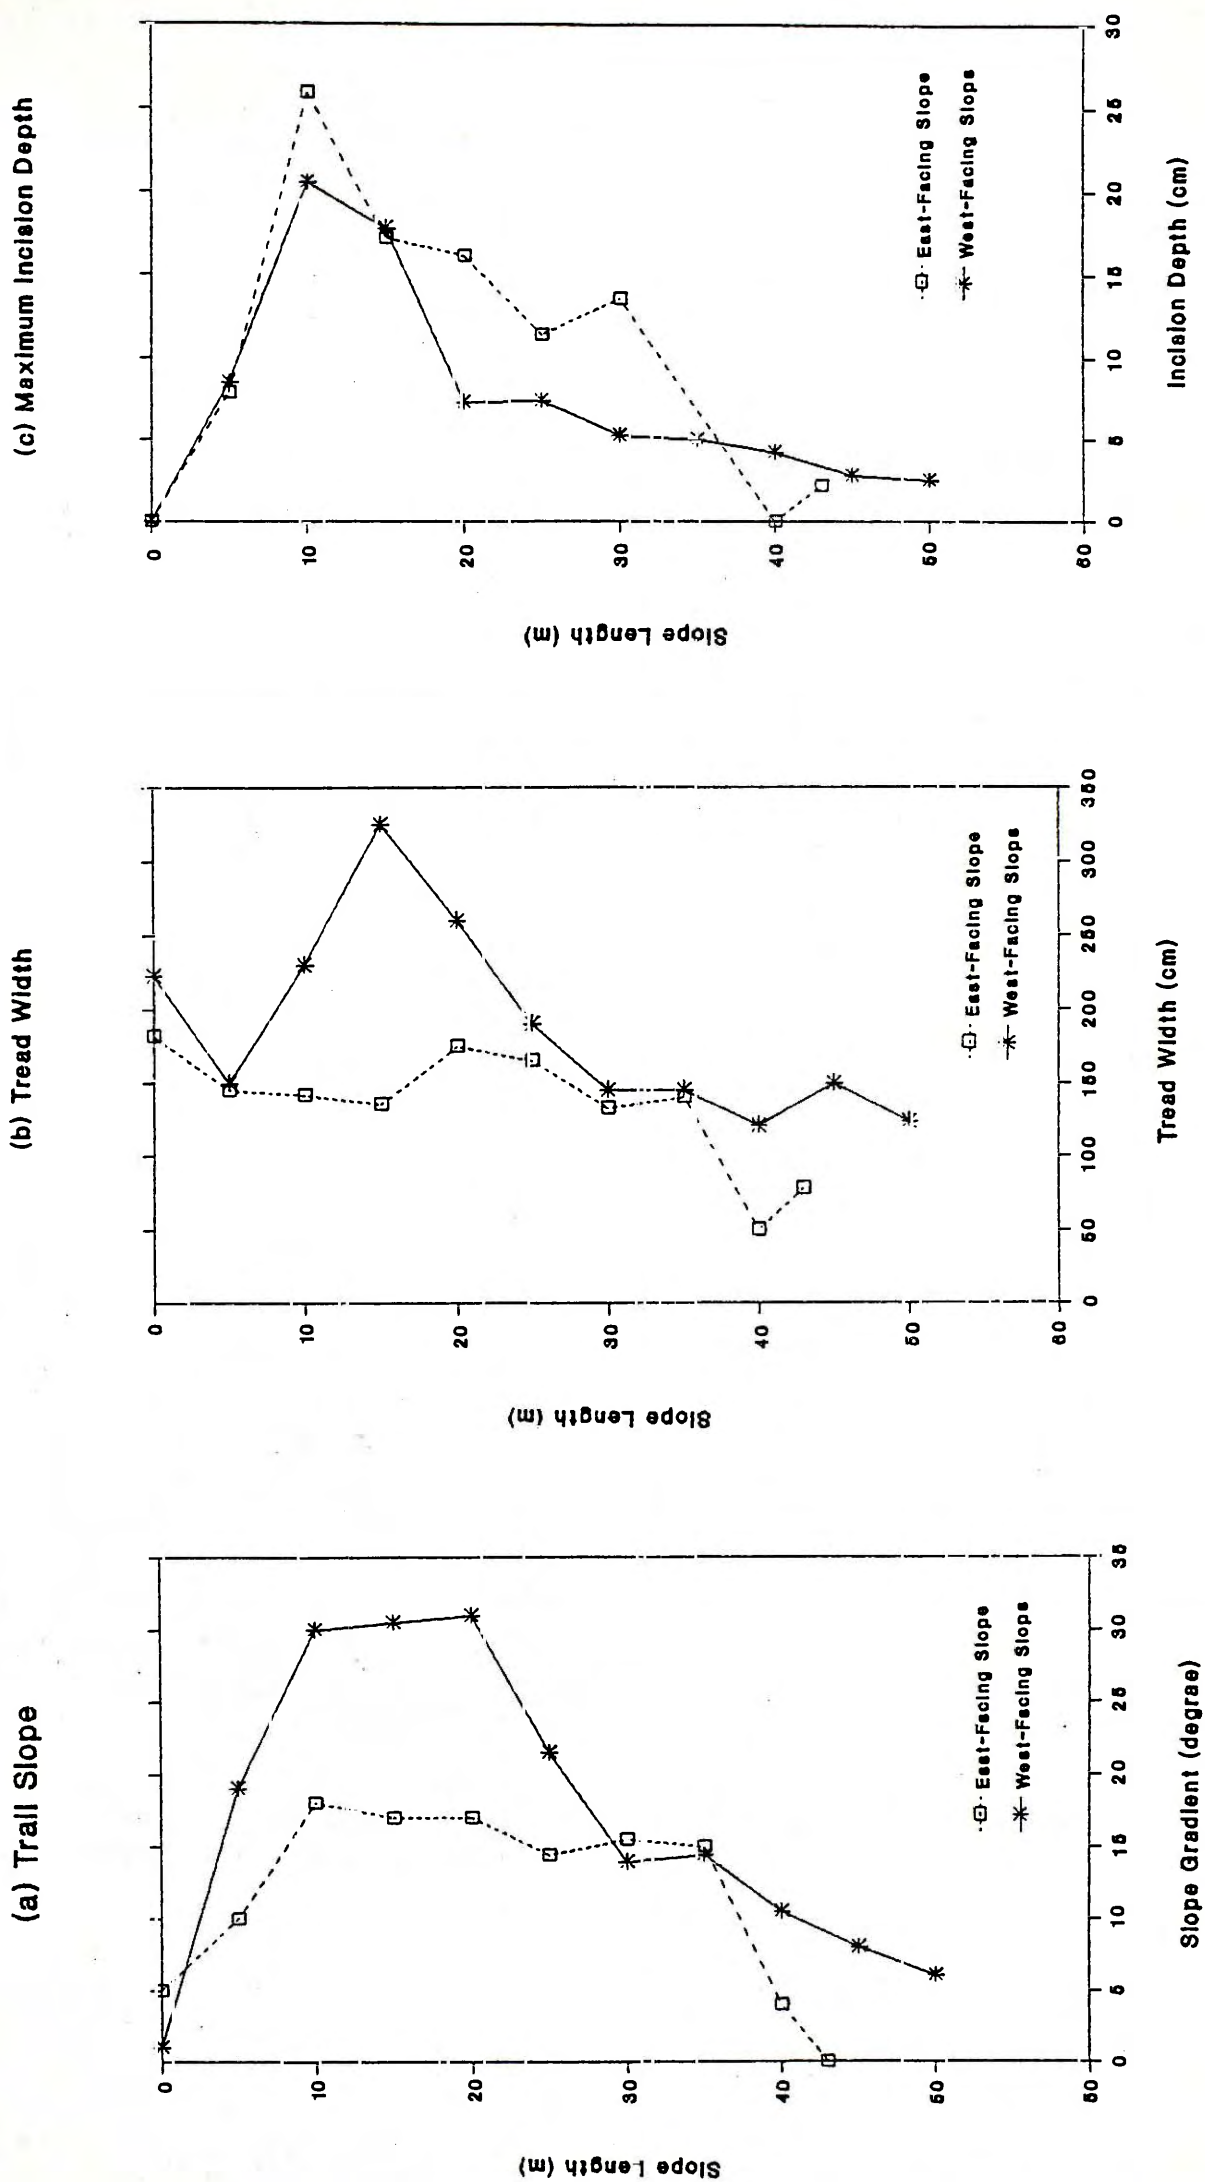
Figure 6.9

Change of slope, width and incision of the trail on the alternate slopes of Choi Wo Fung (at Pat Sin Leng).
